# Impact of sulphide minerals (pyrrhotite) in concrete aggregate on concrete behaviour

**WORKSHOP PROCEEDINGS FROM A NORDIC WORKSHOP**

OSLO - NORWAY, 15. – 16. NOVEMBER 2018

## **WORKSHOP PROCEEDINGS NO. 14**

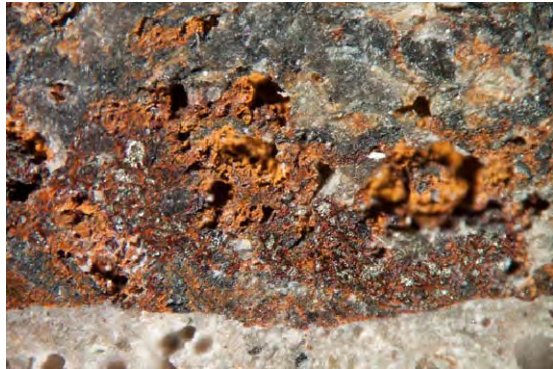
- Case N:o 1 apartment house in Vantaa

- In every case the visible signs were **rusty surfaces and pop outs**.
- The first thought was that it is question about rusty steel bars in the elements.
- But in every case the bars were of stainless steel and the bars were in excellent condition.
- The damages were caused by **sulphide minerals in aggregate**

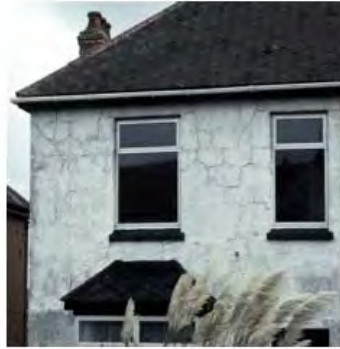
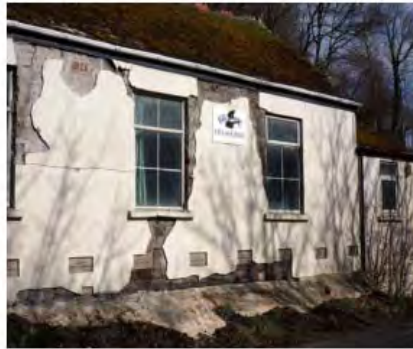
Figure 3: Photographs of two different properties exhibiting characteristic mundic damage

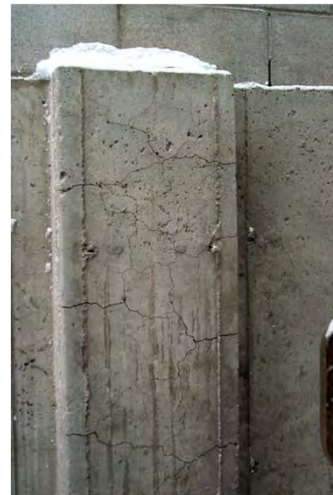
**Rapid (< 3-4 years) deterioration of concrete elements in the Trois-Rivières area (Quebec, Canada)**
