**PUBLICATION NO. 53 2/2015**

# **NORDIC CONCRETE RESEARCH**

| | <b>RESIDUAL CAPACITY OF DETERIORATED CONCRETE STRUCTURES</b> | 33 |

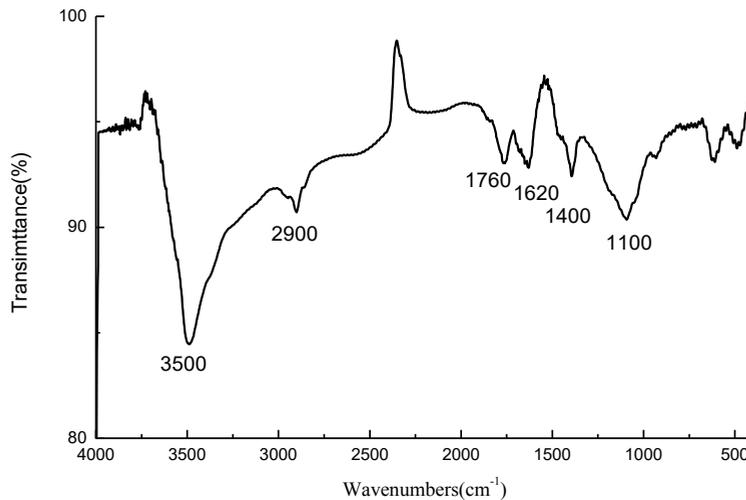
The distinct broad band at 3600-3200  $\text{cm}^{-1}$  attributes O-H. The O-H stretching vibration is normally observed at about 3500  $\text{cm}^{-1}$ , meanwhile the band at 2900  $\text{cm}^{-1}$  is due to the presence of C-H stretching vibration in aliphatic structures. The band observed at 1620 and 1760  $\text{cm}^{-1}$  were assigned to -COO- and -C=O stretching vibrations in aromatic groups, respectively. The band at 1400  $\text{cm}^{-1}$  is due to the presence of -CH<sub>2</sub> angle variable vibration, whereas the wide band around 1100  $\text{cm}^{-1}$  is attributed to the -SO<sub>3</sub> antisymmetric stretching vibration, straight chain C-C and C-O-C stretching vibration. It suggests the presence of sulfo, hydroxyl and carboxyl groups in the molecular of GA. Moreover, hydroxyl groups are hydrophilic and carboxyl groups provide electrostatic repulsion aiming to play retarding effect. In addition, sulfo groups can improve the dispersion properties of GA effectively.

Figure 1 – FT-IR spectra of the examined GA

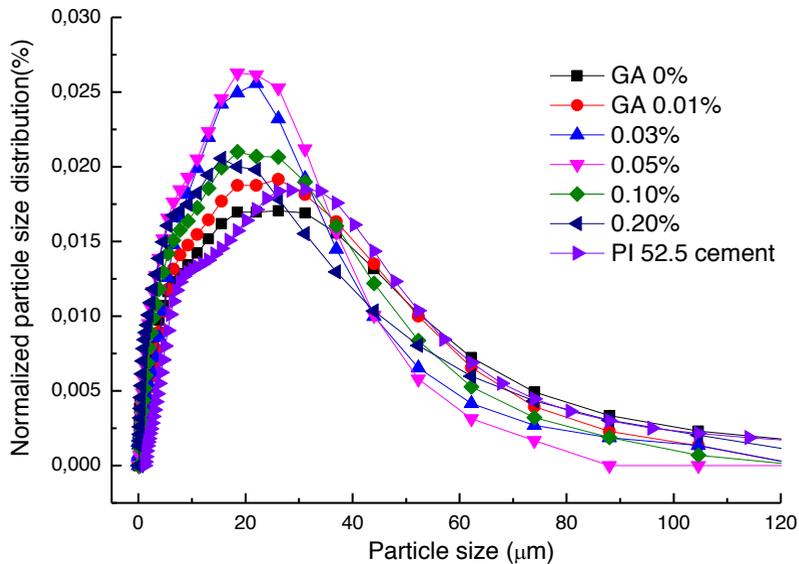
Figure 2 – Influences of dosage on particle size distribution

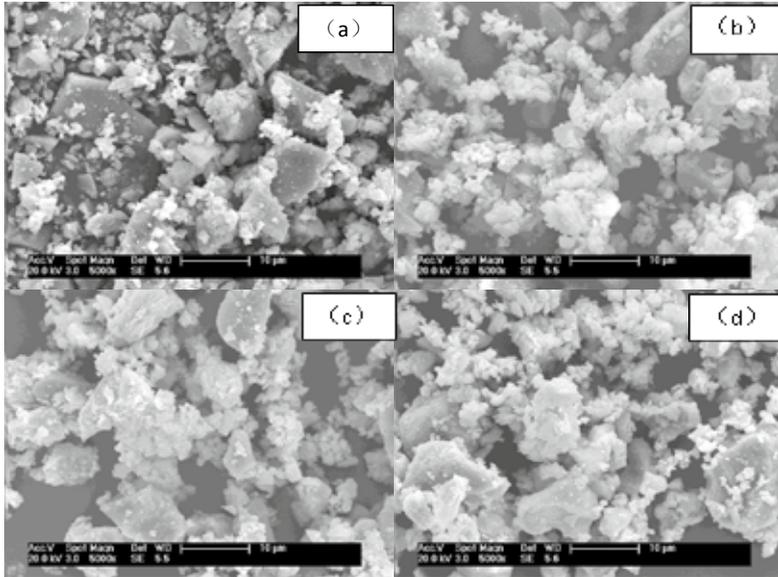
Figure 3 shows a comparison among cement with different dosages of GA. Figure 3 (a) shows that the Ref cement (without GA) presented a heterogeneous mixture of angular particles and the surface has obvious concavo convex. Compared with Figure 3 (a), Figure 3 (b), (c), (d) presented a heterogeneous mixture of spherical particles and the surface slippery. In particular, cement with GA dosage of 0.03% has relative uniform distribution as shown in Figure 3 (b).

Figure 3 – SEM images of cement powder with different GA dosages. (a) 0%, (b) 0.03%, (c) 0.05%, and (d) 0.20%

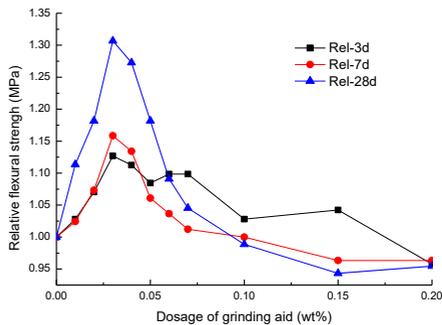
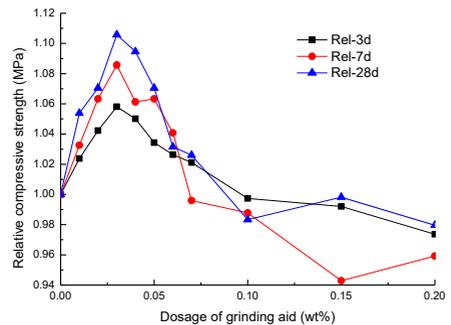
Figure 4 – Flexural strength change as a function of the dosage of grinding aid

Figure 5 – Compressive strength change as a function of dosage of grinding aid

As Figures 4 and 5 shown, it is clearly that the flexural strength and compressive strength are optimal for cement at the dosage of 0.03%. At dosages exceeding 0.03%, flexural strength and compressive strength began to decrease. This signifies that, the optimal particle size distribution contribute a lot to the improvement of cement mortar strength.

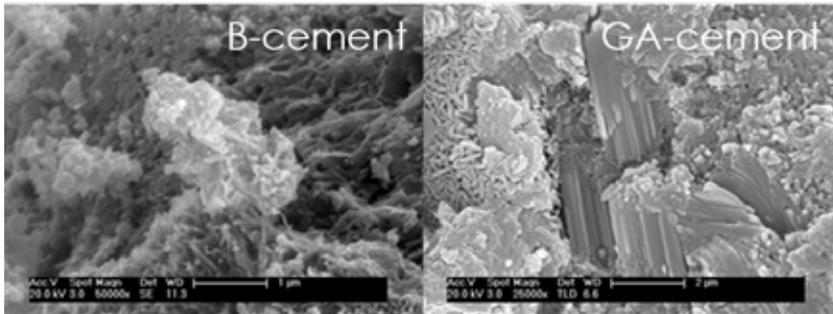
Figure 6– SEM images of cement mortars after 28 days.

As shown in Figure 6, the morphology of sample B-cement appears loosely and more porous, and less small rounded masses of likely ettringite are visible. At the same hydration time, the morphology of GA-cement is completely different: more small rounded and prismatic needle masses are visible, moreover, many needle-like crystals of likely ettringite with different dimensions are present everywhere. This may account for GA-cement having a higher strength than B-cement as shown in Figure 4 and Figure 5.

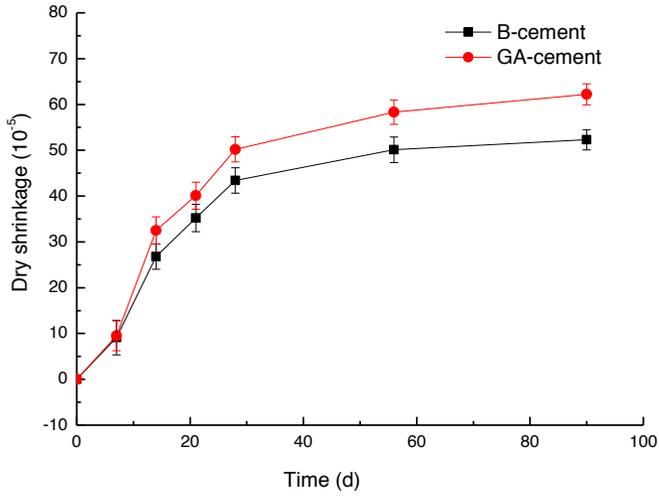
At early age, the dry shrinkage of mortar with GA was similar to Ref mortar, but the gap between them increased gradually with the time prolonged. This is because that at different ages the key factor influencing dry shrinkage may not be the same, that is, the hydration reaction is dominant at the early age, while the pore structure at the late age [15-18]. At the early age both kinds of mortar specimens have similar hydration degree which can be seen from their hydration heat rate as shown in Figure 8. Thus, similar hydration reaction led to the similar increase of the solid phases and at the same time water loss from the larger pores in both the mortars contributed to similar early shrinkage. At the late age, the mortars became more and more dried and the smaller pores began to lose water forming strong contraction. Meanwhile, the hydration reaction has reached a stable stage so that the pore structure became a key factor influencing the drying shrinkage [19]. It can be seen from Figure 9 that, compared with Ref mortar, the mortar with GA contained more micro pores (<10 nm) which could lead to larger contraction due to stronger surface tension in the smaller sizes of pores. This is in agreement with the findings by Mehta and Monteiro [20], that is, capillary pores with diameters less than 50 nm play an important part in drying shrinkage and creep.

Figure 7 – Time-dependent dry shrinkage behaviour from cement mortar

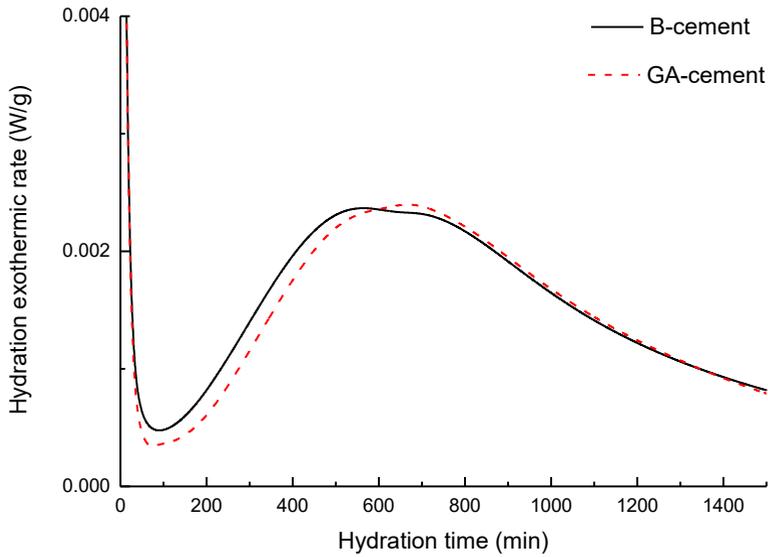
Figure 8 – Hydration exothermic rate curve

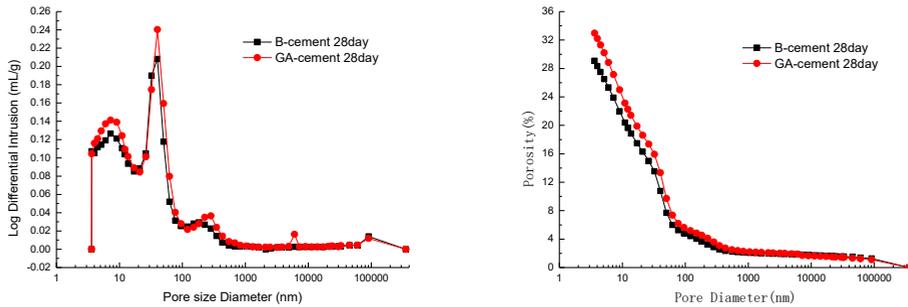
Figure 9 – Pore size distribution and porosity of cement mortars after 28 days hydration

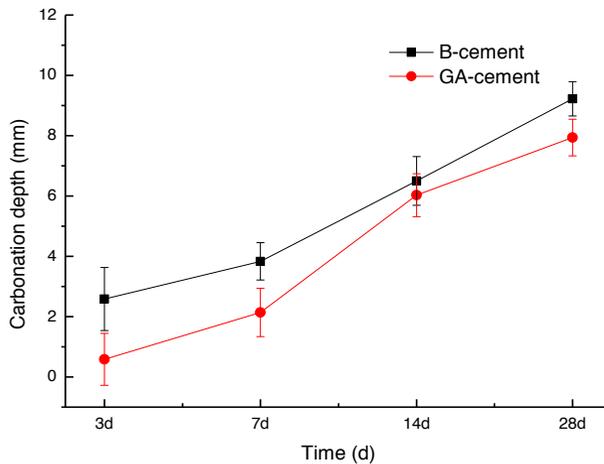
It is demonstrated that the carbonation depth of mortar mixed with GA was lower than that of Ref cement mortar at every carbonation ages. From Figure 11 it can be seen that the specimen with GA revealed slightly stronger intensity of peaks related to  $\text{Ca}(\text{OH})_2$  (noted as CH) than Ref cement mortar after 28 days, indicating a higher degree of hydration, probably due to its finer particle size distribution as shown in Figure 2. This finer particle size of cement with GA might also contribute to its finer pore size distribution after hydration, as shown in Figure 9. Both higher amount of  $\text{Ca}(\text{OH})_2$  and finer pore structure positively increased the resistance to carbonation [21, 22].

Figure 10 – Carbonation depth change as a function of carbonation time.

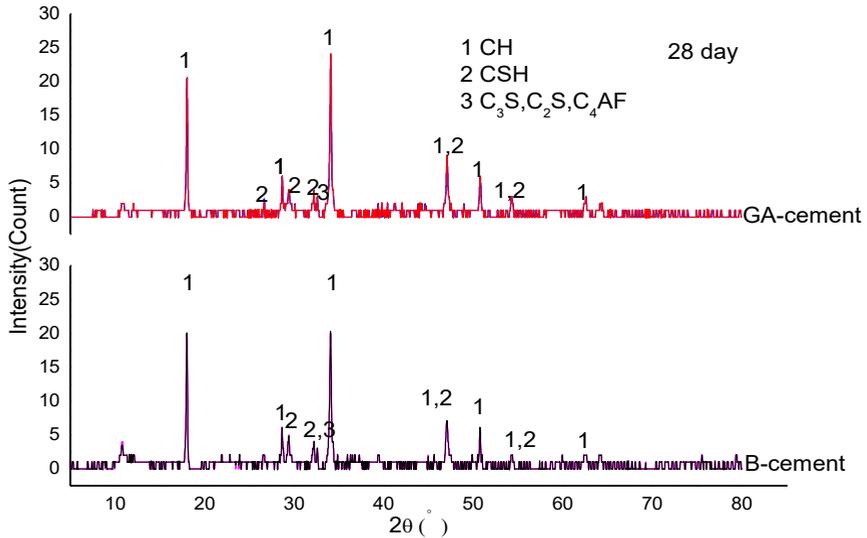
Figure 11 – XRD spectra of cement mortars

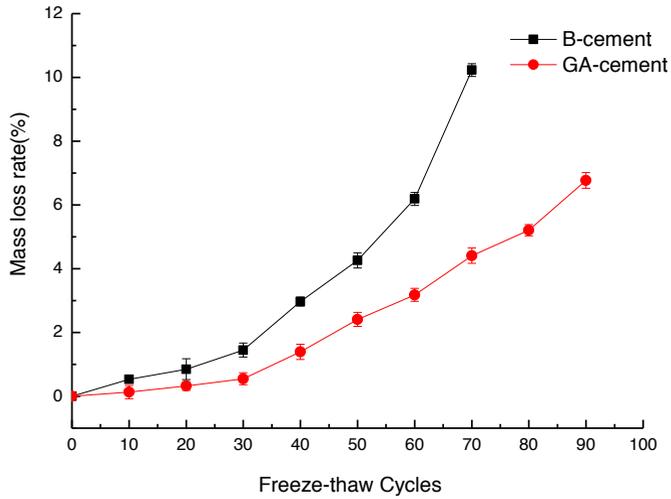
Figure 12 – Mass loss rate under the action of freeze-thaw cycles

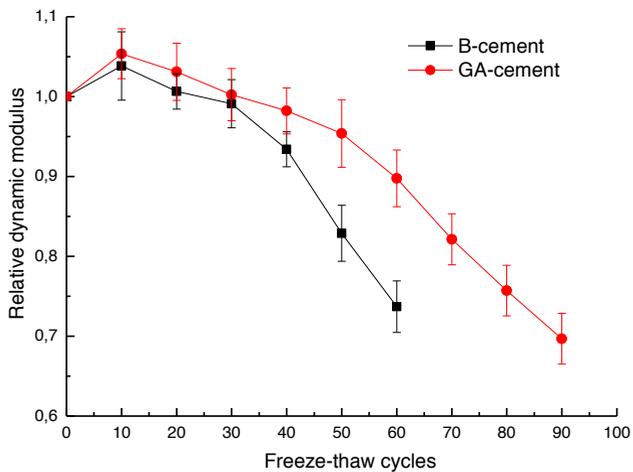
As shown in Figure 13, the relative dynamic modulus of both mortars slightly increased in the beginning, followed by a decrease, especially after 30 and 50 freeze-thaw cycles, respectively for Ref and GA mortars. This signifies that the damages of internal structure of mortar was not apparent under a few of freeze-thaw cycles, under which the internal structure of mortar was further improved owing to the further hydration and thus the relative dynamic modulus increased slightly. The damage of internal structure of mortar became more obvious with increased number of freeze-thaw cycles, which led to a rapid decline of relative dynamic modulus of mortar. Meanwhile, the relative dynamic modulus of Ref mortar declined more significantly than that of the mortar mixed with GA, the former was declined to 75% after 60 freeze-thaw cycles while the latter declined to the similar level after 80 freeze-thaw cycles. The better freeze-thaw resistance of the mortar with GA may also be attributed to its finer pore structure containing more innocuous pores (size <10 nm) [23] and higher strengths, especially its higher flexural strength, as shown in Figure 3.

Figure 13 – Relative dynamic modulus under the action of freeze-thaw cycles

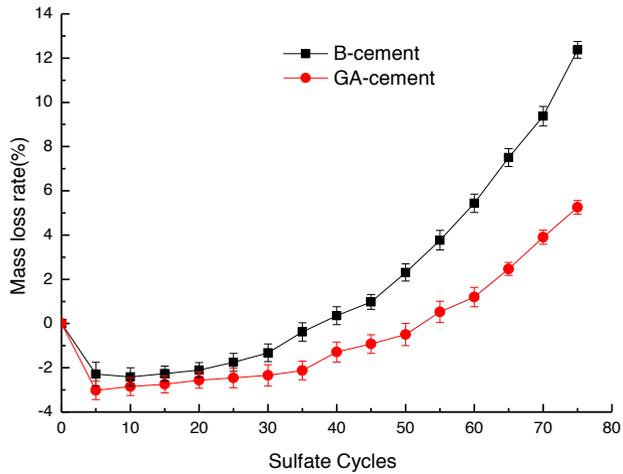
Figure 14 – Mass loss rate under the action of sulphate erosion cycles

As shown in Figure 14, the mass loss rates of both mortars were negative in the beginning, and converted slowly to positive value, followed by a rapid increase after some 40 to 50 cycles. This signifies that the hydration products of both mortars reacted with the sulphate solution generating ettringite or gypsum which led to a mass increase and denser structure by filling internal pores. As a result, relative dynamic modulus increased under the early cycles as shown in Figure 15. Then, the surface layers of both mortars began to scale due to further expanding of hydration products that damaged the structure of mortar after more cycles of sulphate erosion. As a consequence, mass loss rate increased and relative dynamic modulus decreased after 30 cycles. Meanwhile, the mass loss rate of the mortar mixed with GA was always lower than that of Ref mortar while the former's relative dynamic modulus was higher than the latter. This signifies that the resistance of cement mortar to sulphate attack can be improved by mixing with grinding aids.

The results of the sulphate erosion test are shown in Figures 14 and 15.

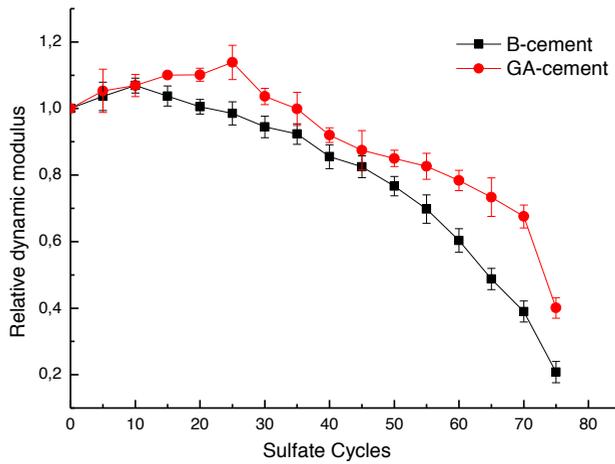
Figure 15 – Relative dynamic modulus under the action of sulphate erosion cycles

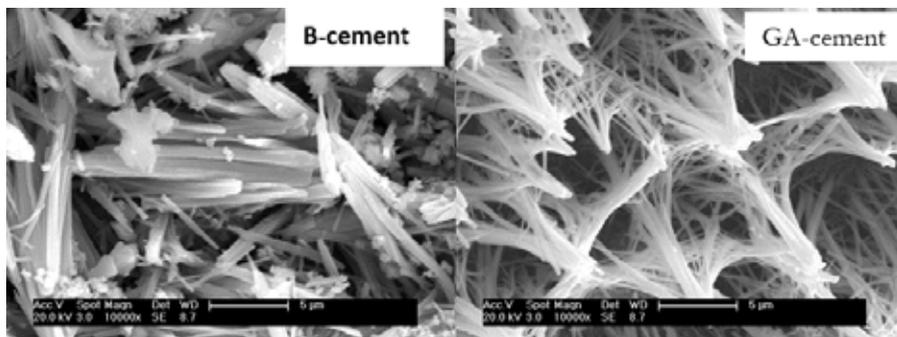
Figure 16 – SEM images of mortars after 30 cycles of sulphate erosion

As shown in Figure 16, the ettringites generated in Ref mortar were thick and heavily piled together, which might strongly expand to damage the structure of mortar, while the ettringites generated in the mortar mixed with GA appeared thin and loosely glued together, which could fill in the internal pores and improve the compactness of mortar [24-25]. The formation of thinner ettringites in the mortar mixed with GA is also attributed to its finer pore structure which reduced the ingress of sulphate ions and retard the formation rate of ettringite.

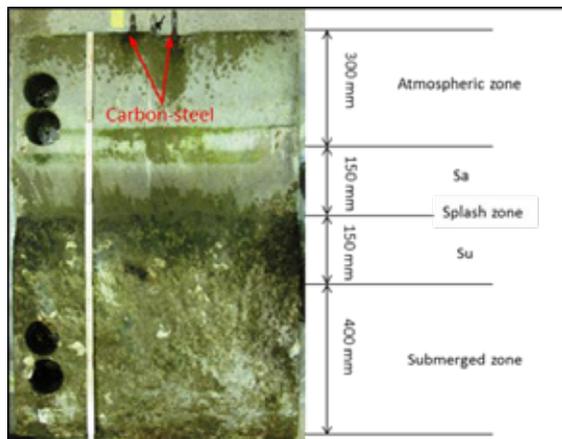
Figure 1. Concrete slab after 20 years of exposure and the division in different exposure zones.

The exposure condition of the slabs was divided into three major zones as illustrated in Fig. 1, an atmospheric, a splash (further sub-divided into three zones) and a submerged zone. The splash zone was as mentioned divided into three zones: a zone mostly above sea level (Sa), a zone at sea level (splash), and a zone mostly below sea level (Su). For all concrete slabs one core for chloride profile was taken from the submerged zone, for some slabs cores from up to four exposure zones were taken. More details about the sampling, chloride and calcium analysis can also be found in [7] Hence, the calcium content also was determined for each individual sample (parallel with the chloride content), the CTVs in this study are expressed as total chloride content relative to the weight of binder.

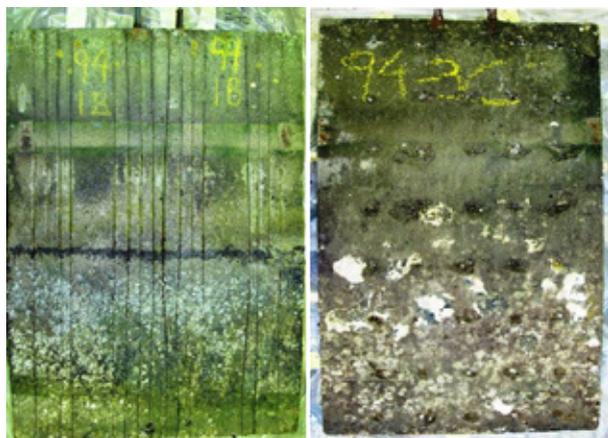
Figure 2. Concrete slabs with simulated cracks. Left slab with “Artificial cracks” and right slab with so-called “Natural cracks”.

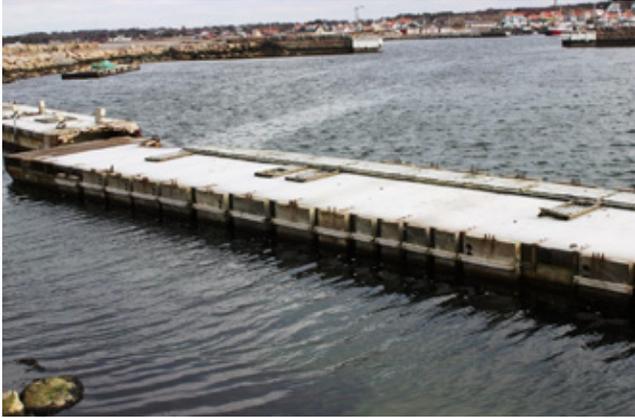
After moisture curing for about two weeks, the slabs were transported to the field site (located in southwest Sweden) and mounted on the sides of pontoons for exposure with the bottom side of the slab facing the seawater (Fig. 3). The chloride concentration in the seawater varies from 10 to 18 g Cl<sup>-</sup> per litre, with an average value of about 14 g Cl<sup>-</sup> per litre. The water temperature has an annual average of +11°C.

*Figure 3. Overview of the field site.*

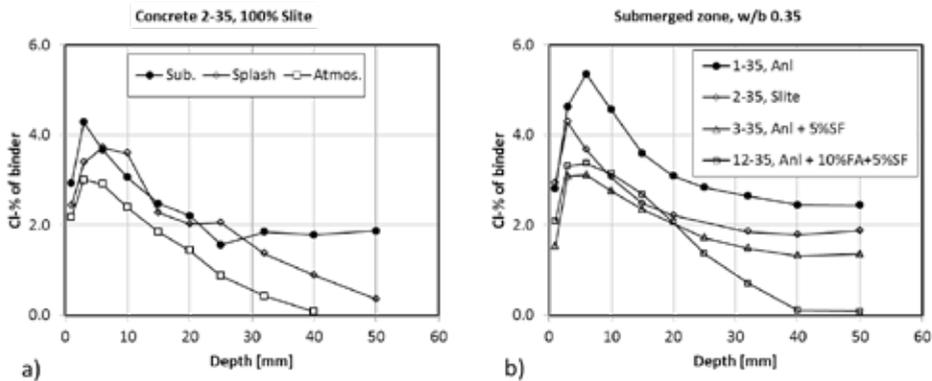
Figure 4 shows the chloride ingress in some slabs after 20 years of exposure in marine environment. Both the dependency of the exposure zones as defined in Fig. 2 and the effect of the binder (binder compositions are given in the following text) on the chloride ingress is elucidated in Fig. 4. The result showed that the chloride ingress was in general more severe in the submerged zone, and that pozzolanic additions such as fly ash and silica fume can effectively reduce chloride ingress. Further details on the development of chloride ingress through the 20 years of exposure and validation test of two prediction models are given in [7].

Figure 4. Profiles of chloride ingress in the concrete slabs after 20 years of exposure in marine environment. a) The dependency of exposure zone. b) The effect of binder type.

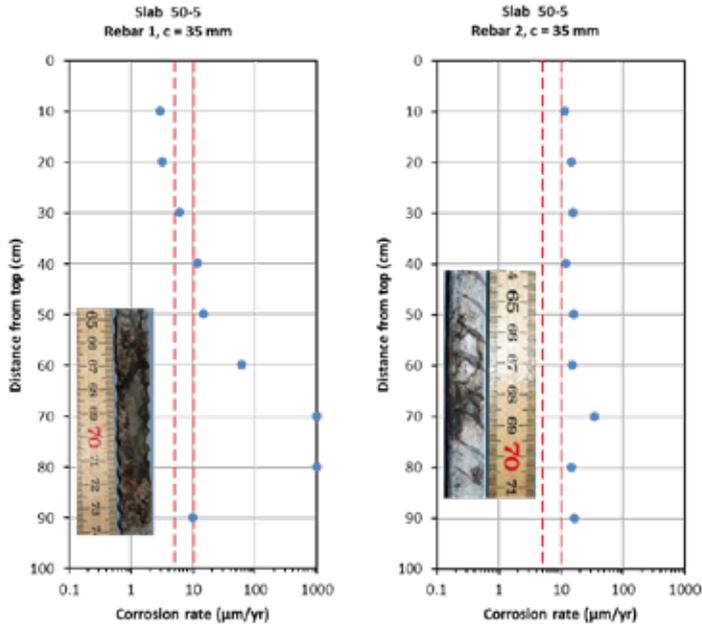
Figure 5 shows examples of corrosion rate measurements and photographic images from the visual examination. Also in Fig. 5 the corrosion rate limits (dashed red lines) dividing passive ( $\leq 5 \mu\text{m/yr}$ ) and active ( $> 10 \mu\text{m/yr}$ ) corrosion are plotted. Each rebar was measured at nine locations at an interval of 10 cm from the top edge of the concrete slab. As the previous investigation [8] from the same field site has shown, the corrosion rate is the most accurate way to identify the corrosion condition of the embedded rebars. Both corrosion potential and

concrete resistivity give greater response to the environment of the exposure zone rather than to the corrosion condition of the rebar. In the following only the corrosion rate will be addressed to for the evaluation of the corrosion condition.

Figure 5. Photographic images from the visual examination of detached rebars from slab 50-5 and corrosion rate measurements.

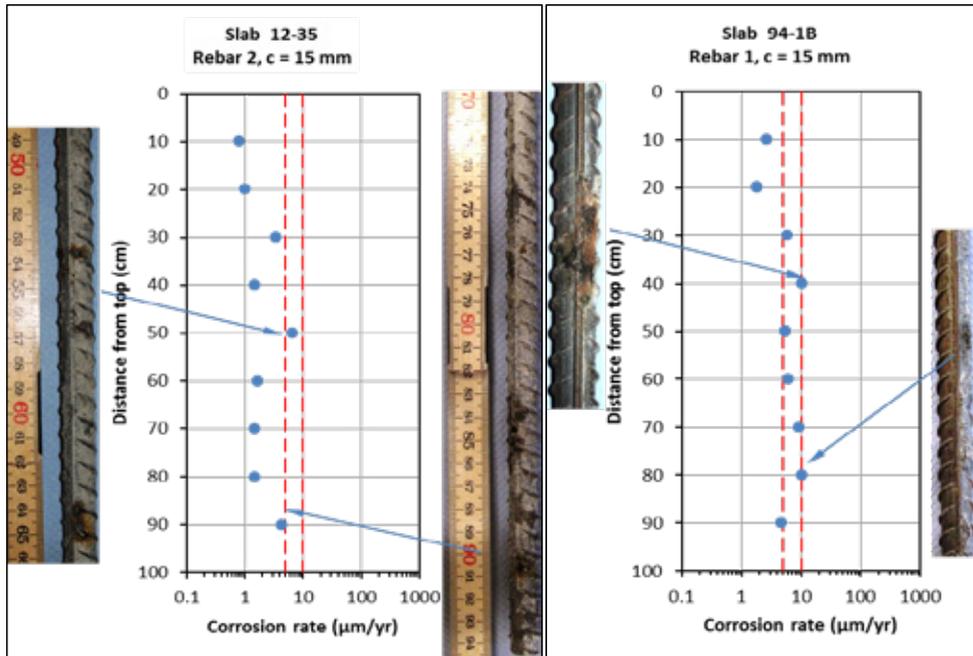
Figure 6. Photographic images from the visual examination of detached rebars from slab 12-35 (left hand side) and from slab 94-1B (right hand side) with corresponding corrosion rate measurements.

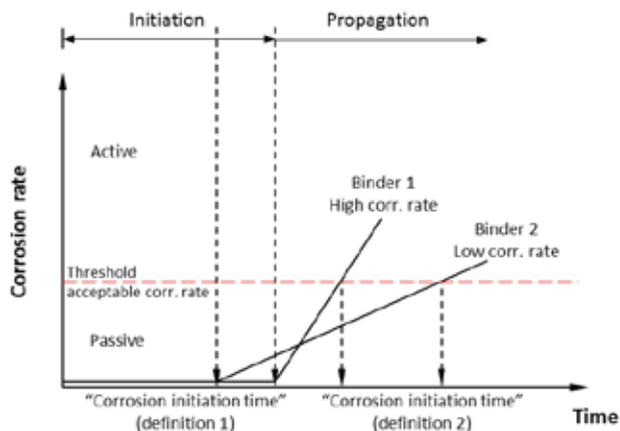
Figure 7. The influence of the corrosion rate on the “corrosion initiation time” as consequence of the adopted definition of the CTV (Fig. based on Tuutti’s model).

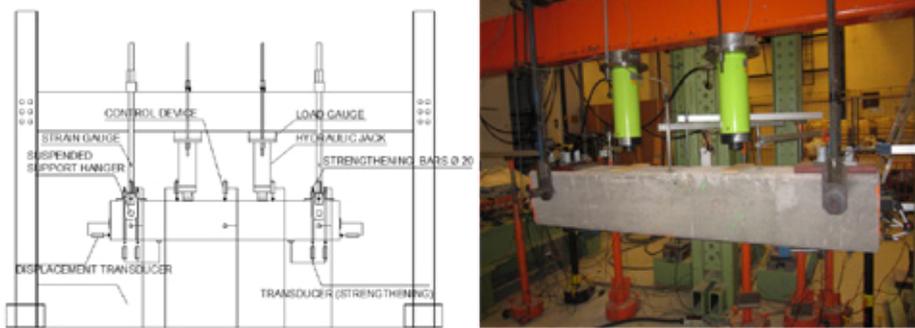
The experiments have been carried out at Chalmers University of Technology. The test setup and the test results are described in detail in [5] and [6]. The specimens were extracted from the edge beams of an existing girder bridge with a concrete slab; the edge beams showed different levels of corrosion-induced damage. Based on the damage patterns, the specimens were categorized in three different groups: Reference (R) beams with no visible damage, Medium (M) damaged specimens with only splitting cracks, and Highly (H) damaged specimens with spalling of the cover. One of these experiments (specimen M4) is presented and compared with the FE analysis in this paper. The drawing and a photo of the designed test set-up are shown in Figure 1.

Figure 1 – Photo and drawing of the indirectly supported four-point bending test.

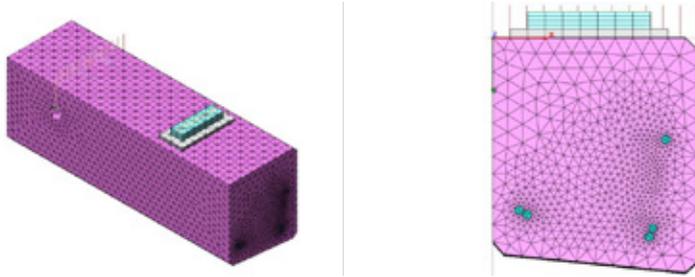
3D non-linear finite element analyses were performed to describe the behaviour and capacity of the anchorage regions. The commercial software DIANA with pre- and post-processor FX+ was used for the numerical simulations. 3D tetrahedral elements were used for both the concrete and the tensile reinforcements. The interface elements were used to model the interaction between the concrete and reinforcements. The frictional bond and corrosion models were implemented in the interface elements. The models used for bond and corrosion were developed by Lundgren [7] and further developed by Zandi [8]. Due to symmetry, only one half of the beam was modelled as shown in Figure 2.

Figure 2 – Overview of the FE model.

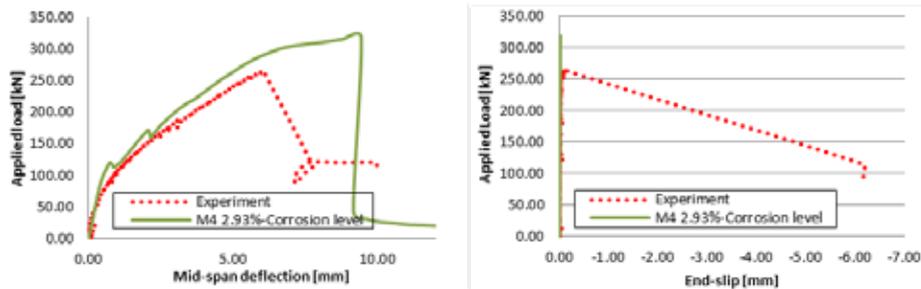
The results from 3D FE analysis, see Figure 3, show a different failure mode than the splitting pull-out failure occurred in the experiment. In the FE analysis, the reinforcement was yielding and the maximum load capacity was overestimated. Moreover, the end-slip was not triggered in the reinforcements.

Figure 3 – Results of 3D FE analysis in comparison with the experiment.

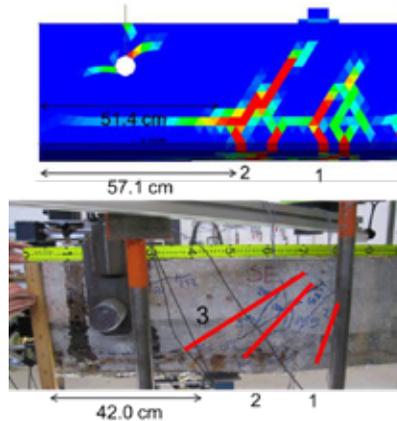
The results of the analysis showed differences in the shear crack pattern in comparison with the experiment, see Figure 4. As can be seen, there were two shear cracks in the experiment (marked with numbers 2 and 3 in the figure), while there was only one shear crack in the analysis. Thus, a longer remaining anchorage length was obtained in comparison with the experiment which increased the anchorage capacity and resulted in a wrong failure mode. This issue might be related to the influence of aggregate interlock in FE analysis. For more information, see [9].

Figure 4 – Comparison of the crack pattern for the beam M4; the remaining anchorage length is given in cm.

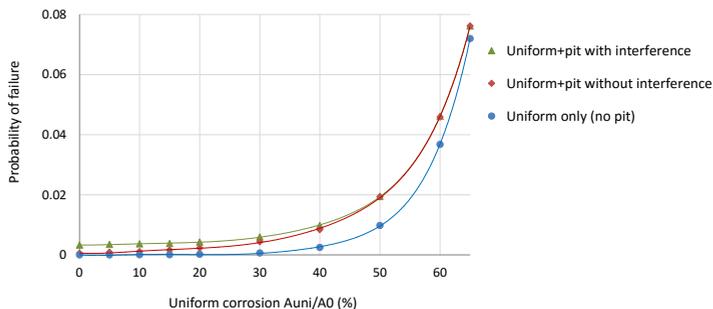
Figure 1 illustrates the  $P_f$  of the corroded RC beam for different assumed values of uniform corrosion. The results are presented for three mentioned cross-sectional reduction models. According to results, taking into account the localised corrosion (red rhombs in Figure 1) and the interference of localised corrosion (green rectangles in Figure 1) in the analytical design rules have substantial influence on the  $P_f$ . On the other hands, model with only uniform corrosion without taking into account the spatial variation of pits (blue circles in Figure 1) results in an under estimation of the  $P_f$ .

Figure 4.3 – Probabilities of failure with different assumption of uniform corrosion for models with a) only uniform cross section reduction, b) uniform cross section reduction with spatial variation of pits without interference and c) uniform corrosion cross section reduction spatial variation of pits with interference.

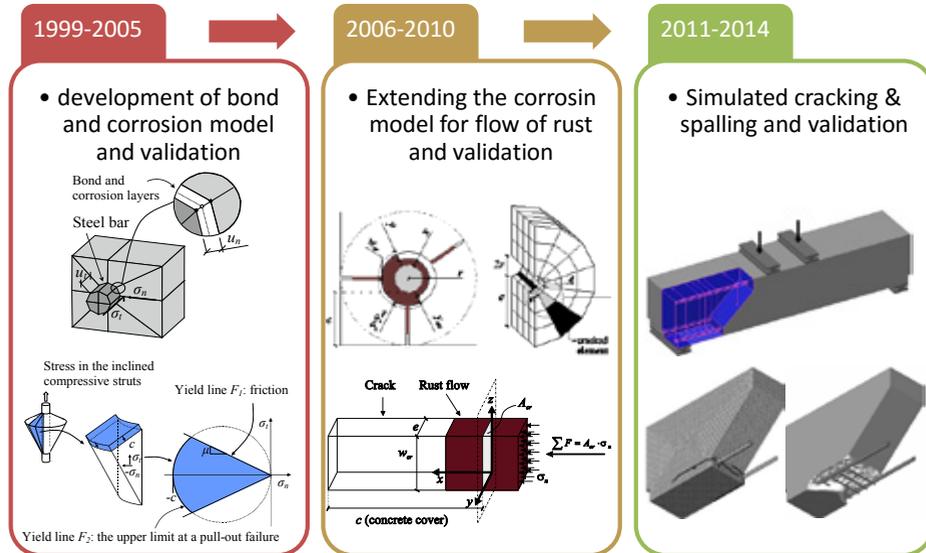
Figure 1. Overview of the earlier developments of deterioration model including major milestones.

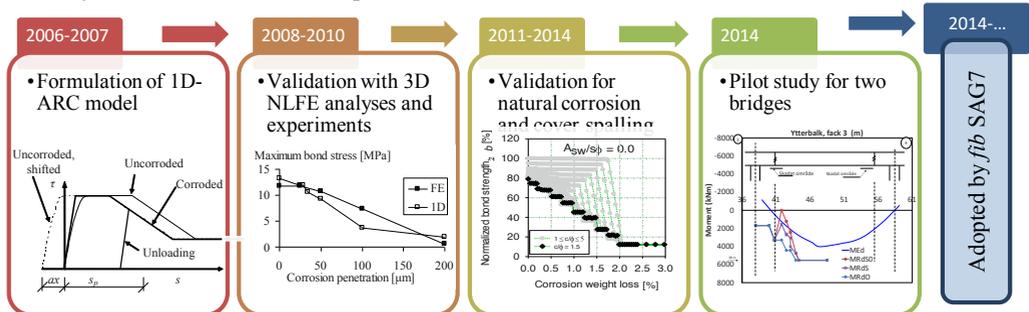
Code 1990 [7] combined with a parametric study using 3D NLFE analyses and several experiments [6]. The model was later verified by results from test specimens with natural corrosion [8]. Moreover, the model was recently validated by 3D NLFE analyses and experiments for high corrosion attacks leading to cover spalling [5]. This model was even applied in practice in a pilot study including two bridges, thereby demonstrating its excellent potential for practical use; this is further discussed in section 4. Moreover, the 1D-ARC model has recently been adopted by fib-SAG7 – Modelling of structural performance of existing structures – to be included in the planned Model Code for the assessment of existing structures. This demonstrates that the model has been internationally recognized which can be considered as a major milestone in the development of the model.

Figure 2. Overview of the earlier developments of the 1D-ARC model including major milestones.

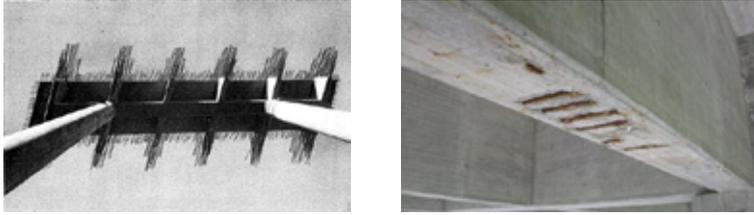
The methodology is exemplified in assessment of two bridges, “Blommenbergsviadukten” and “Gröndalsviadukten”, bridges in Stockholm built in the 1960s. The bridges were built in phases; the first phase consisted of columns, cross beam, and a part of the superstructure, see Figure 3. Thereby, a cast joint was placed at each main beam on either side of each row of columns. This led to that large amounts of reinforcement were spliced at each cast joint; see Figure 3. Today, the bridges exhibit systematic damage in the form of spalled concrete on the bottom side of the main beams at these cast joints; an example is shown in Figure 3. At the assessment of the bridges, sufficient capacity could be shown if the structure was assumed to be undamaged. Considering the visible damages, this was however considered to be an unrealistic assumption. As the documented damages are located close to points where the bending moment is zero, it was first examined whether a simplified assumption that the bond strength was zero in the damaged areas would be enough; however, this conservative assumption resulted in insufficient capacity. Accordingly, a more detailed investigation on the anchorage in the damaged sections was needed. Thus, the model by Lundgren et al. [6] was applied. The bond versus slip was obtained first, and the anchorage length was calculated by numerical solving the basic 1D bond-slip differential equation along a bar.

Figure 3. Left: Photo from the time of construction, showing the large amount of reinforcement spliced at the cast joints. Right: Example of a damage with spalled cover at a cast joint at the bridge today.

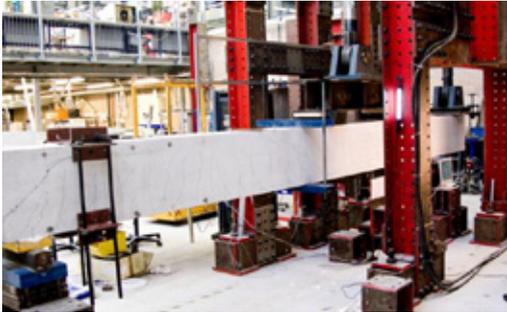
properties of today. For old concrete it was possible to get another relation between both mentioned strengths. Also the shear force behaviour between both beams and the extension to slabs was part of this experimental program. Figure 1 shows the setup of the beam experiment, figure 2 shows the setup of the slab experiment.

*Fig.1: Beam experiment*

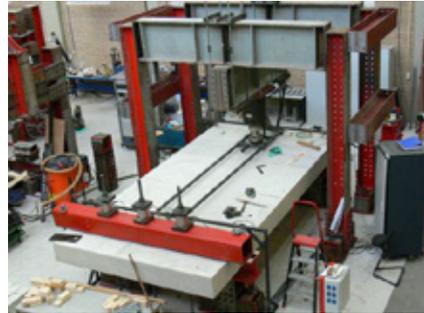
*Fig.2: Slab experiment*

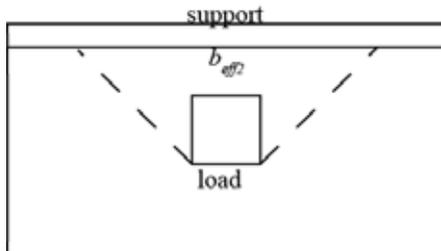
The result of the slab experiments was a modification of the force flow from the wheel print load to the support line. This French load spreading method is demonstrated in figure 3. An additional tool for experiments in-situ is the use of acoustic emission sensors, to get a sign of cracks in the concrete by loading a slab or a beam. In-situ are many expected and disturbing for the experiment sources of noise, where the lab circumstances are rather pure. Figure 4 gives a bottom view of a slab where sensors are installed to get the mentioned crack noise.

*Fig.3: French load spreading method sensors*

Both figures 3 and 4 are very helpful to make some predictions and postdictions of proofloadings of slabs in situ. Figure 3 helps to locate the wheelprint load on the top surface of the bridgedeck, where the sensors catching the crack noise spreading over the slab. The proofloading of a slab is the last chance to keep the object in the highway network. When the re-examination analysis doesn't reach the desired reliability of the object, coming from the current checking recommendation, only the proofloading can save the object. Different ways of setup of proofloadings are already used. Figure 5 shows a quick and dirty setup, a fixed setup and a movable setup.

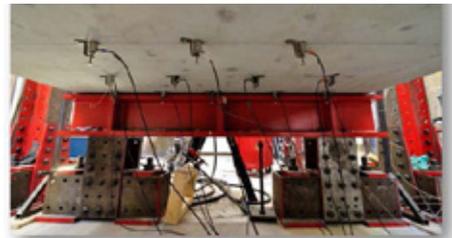
*Fig.4: Bottom view slab with acoustic emission sensors*

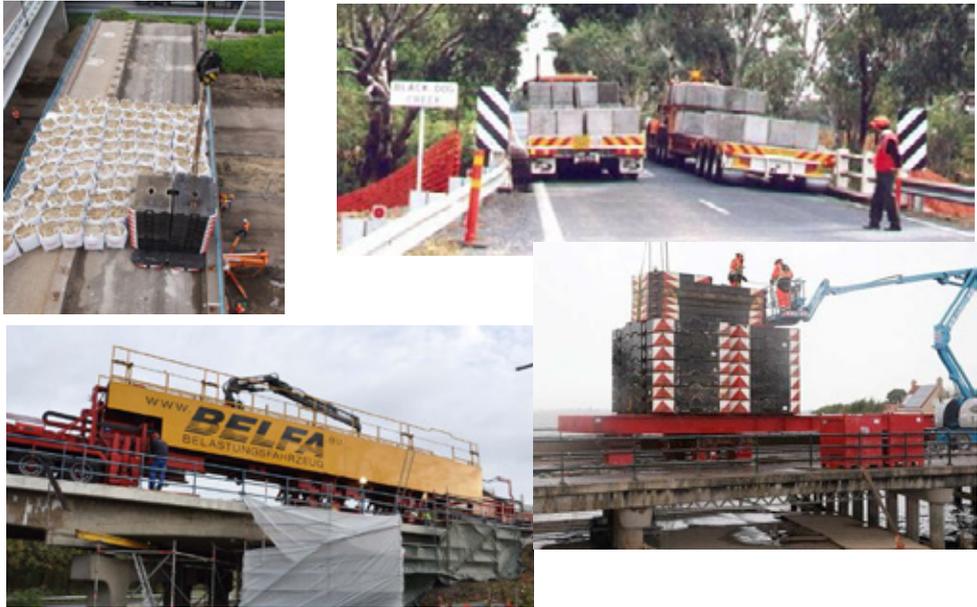
*Fig.5: Different setups proof loading slab viaducts*

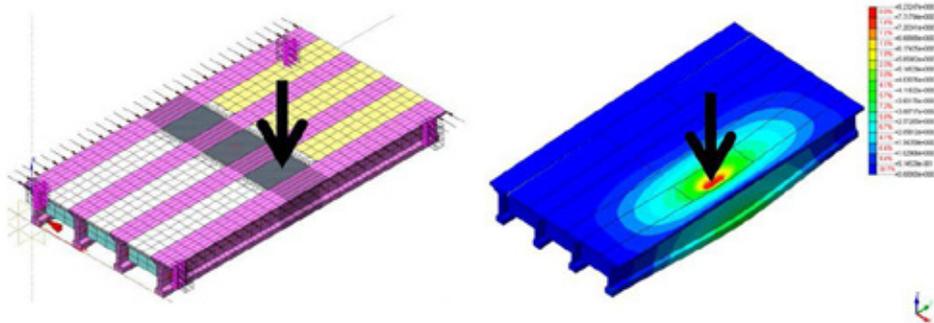
international contest on the failure of one of the T-beams shows a very small scatter in ULS load. Numerical nonlinear finite element analysis is often used for predictions and postdictions of the behaviour of failure of structures. The checking methods are now described by the safety format procedures in the ModelCode 2010. Figure 6 gives a view of the model of the prestressed T-beams and transversal prestressed slab panels between the T-beams, experimented at the Delft University of Technology.

Fig. 6: Wheel print load on slab panels located between T-beams

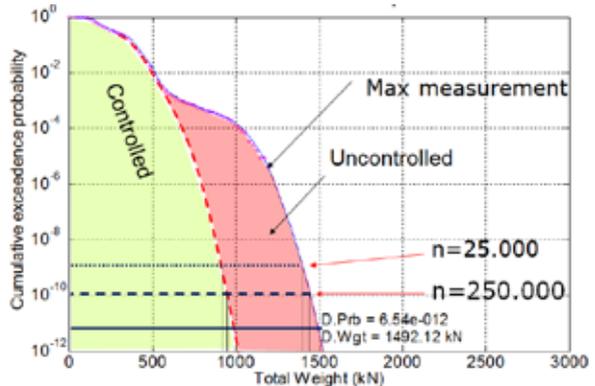
Till now the material side had the focus at the previous chapters, but the variable traffic load side is also an important research subject. Today on twenty locations the traffic passages are measured. Axle loads and speed of axles are measured, where vehicles, speed of vehicles and intermediate distances between axles and vehicles are derived. This leads to a prediction of the axle and vehicle load of the remaining period of an existing structure. This can be illustrated by figure 7. The figure shows a maximum Eurocode vehicle design load of 1500kN during 100 years of lifetime with 2.5million passages each year. When the passages of vehicles is less the vehicle load will be decreased.

Fig. 7: Prediction of the Eurocode vehicle design load

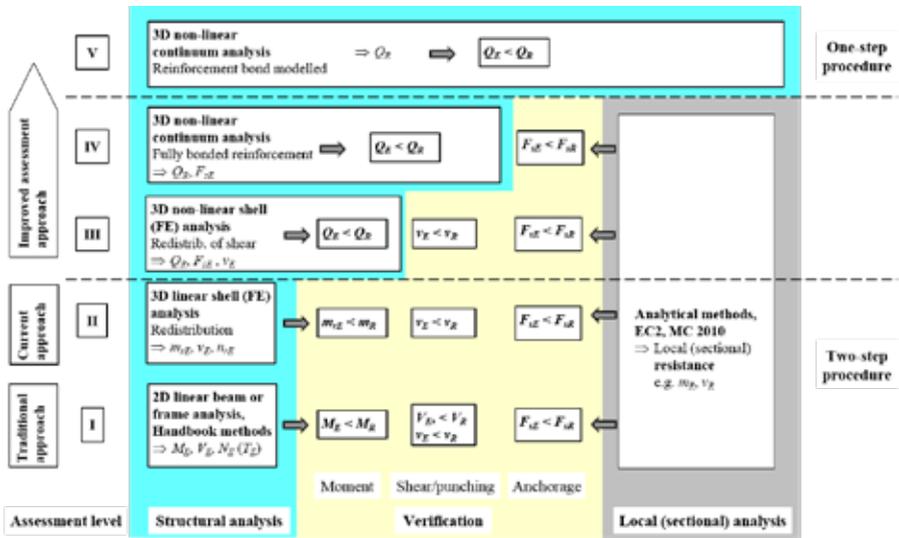
Figure 1. Scheme for multi-level assessment of reinforced concrete bridge deck slabs

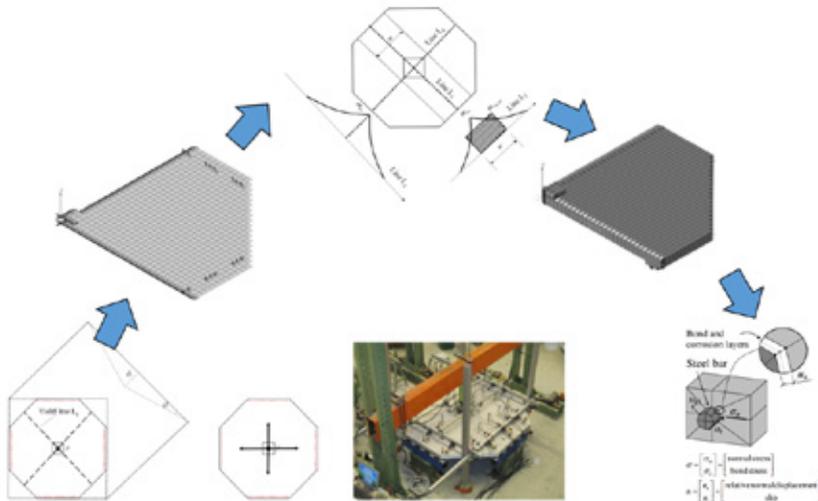
Figure 2. Case 1: application to two-way slabs subjected to bending failure

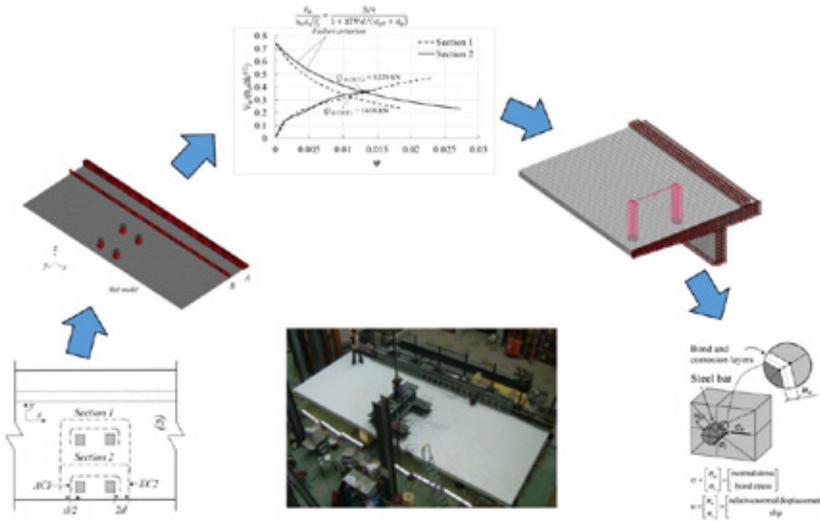
Figure 3. Case 2: application to a cantilever slab test

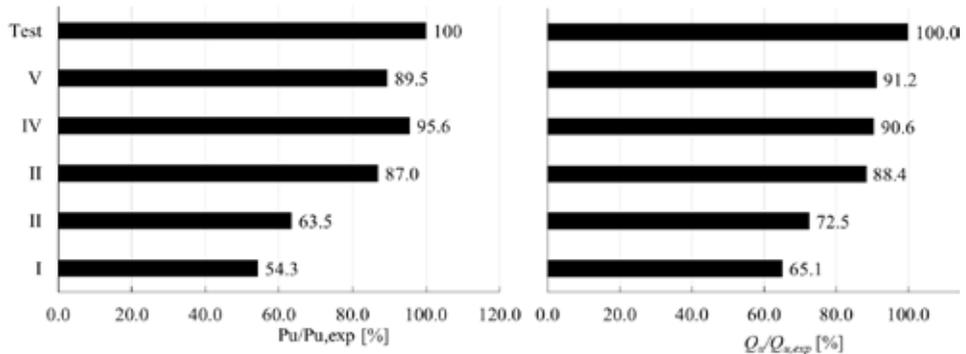
Figure 4: Load-carrying capacity of two-way slabs (left) and a cantilever slab (right) at different levels

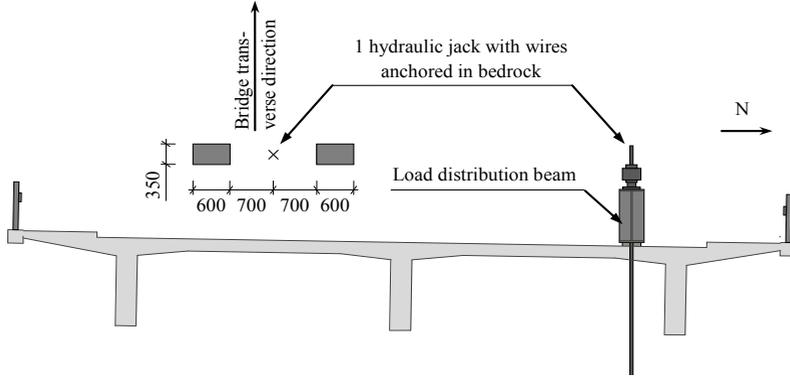
Figure 1: Arrangement for loading the bridge deck slab.

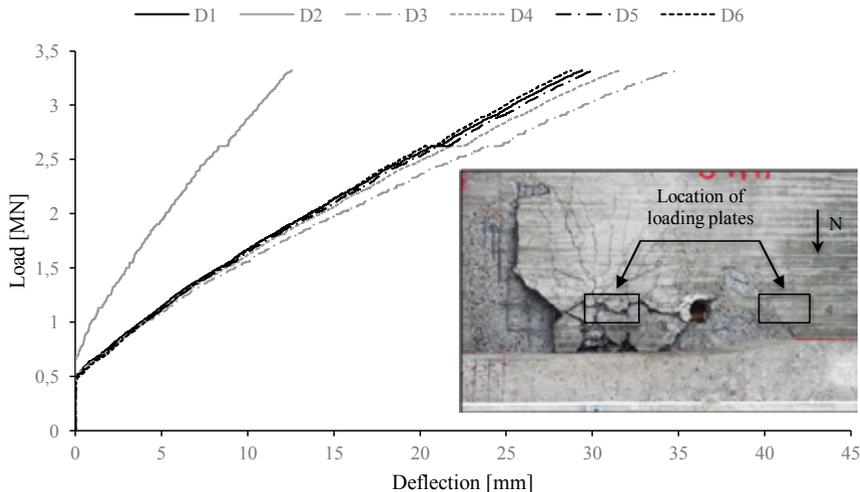
Figure 2. Measured load-deformation curves and photograph of punching failure (2014-07-01).

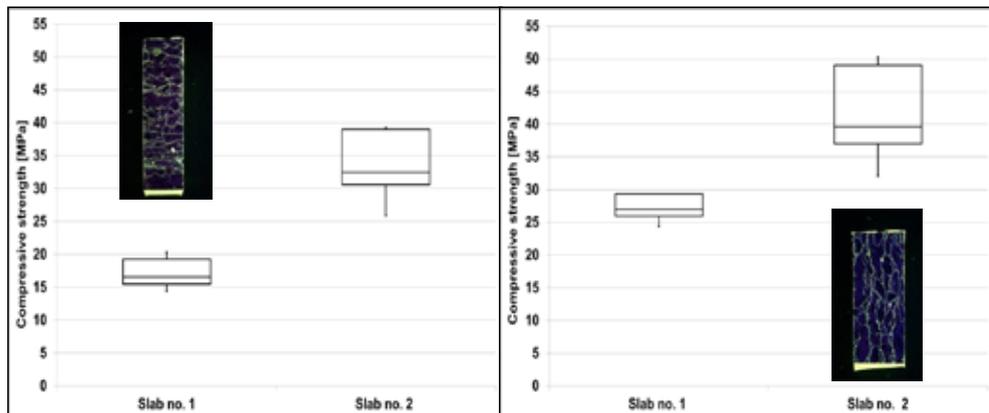
Figure 1: Compressive concrete strength for slab no. 1 and 2. Left: Compressive strength of vertically drilled concrete cores. Right: Compressive strength of horizontally drilled concrete cores.

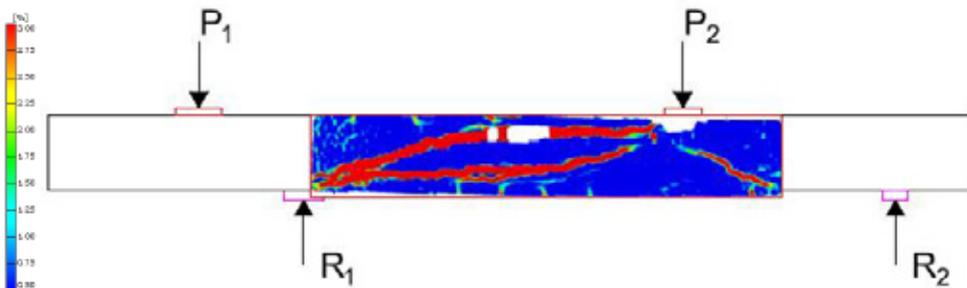
Figure 2: Asymmetric 4 point bending and ARAMIS plot for a severe ASR damaged beam.

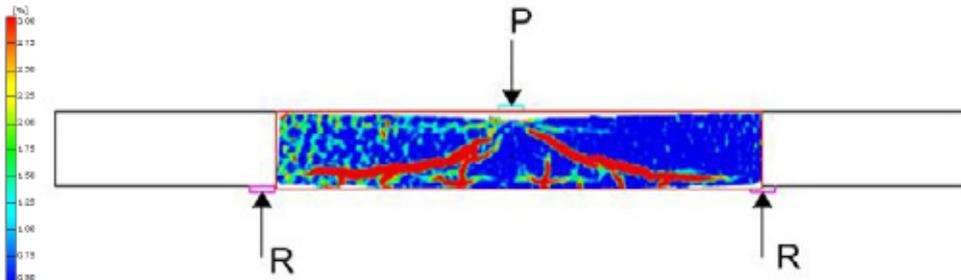
Figure 3: Symmetric 3 point bending and ARAMIS plot for a severe ASR damaged beam.

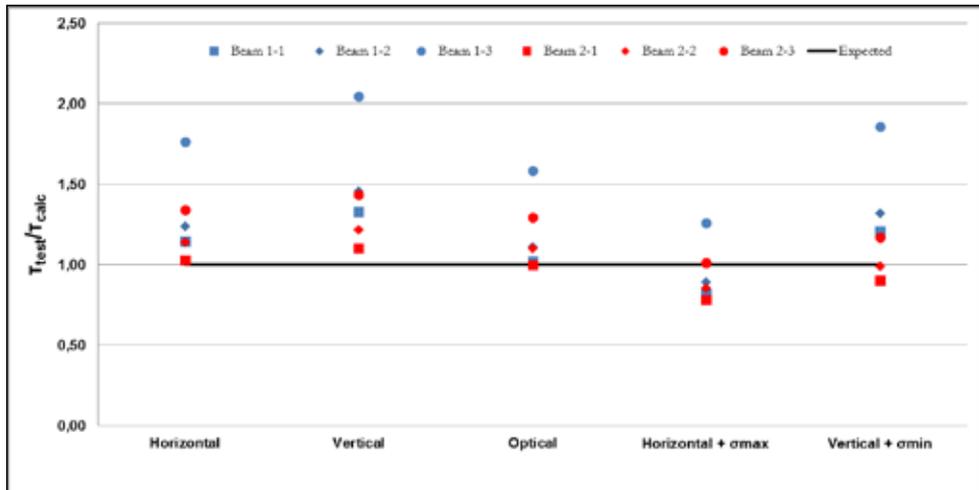
deviation might be due to an arch effect and a combination of bending and shear failure which the shear model in Eurocode 2 does not take into account.

Figure 4: Tested shear capacity compared to calculated shear capacity based on Eurocode 2 shear model.

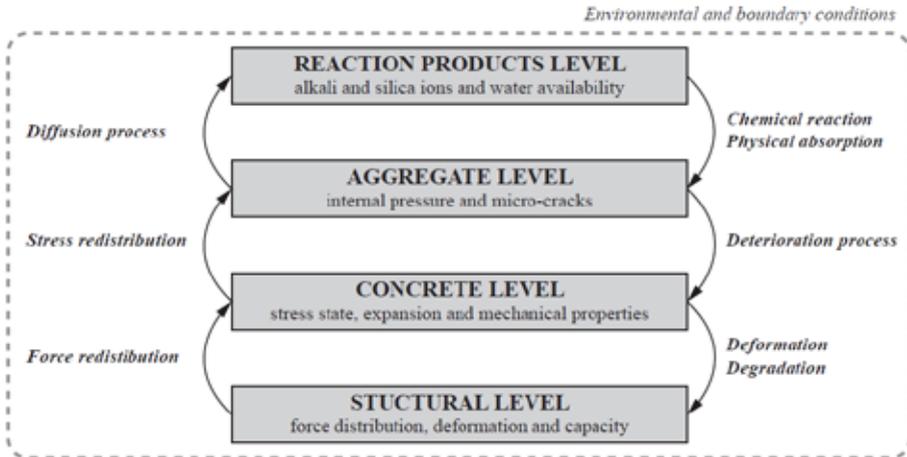
Figure 1: The alkali-silica reaction in concrete structures: interaction of the various phenomena at the different scales (Esposito, 2016).

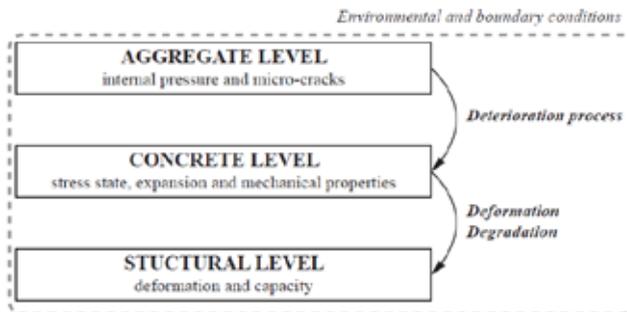
Figure 2: Scope of the present research (Esposito, 2016).

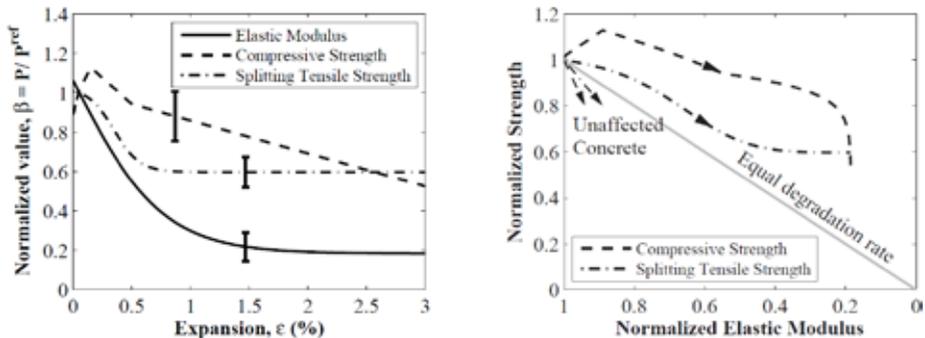
Figure 3: Summary of experimental results. Relation between normalised mechanical properties and concrete expansion and relation between normalised elastic modulus and normalised strengths (Esposito, Anaç et al., 2016).
