**PUBLICATION NO. 53 2/2015**

# **NORDIC CONCRETE RESEARCH**

| | <b>RESIDUAL CAPACITY OF DETERIORATED CONCRETE STRUCTURES</b> | 33 |

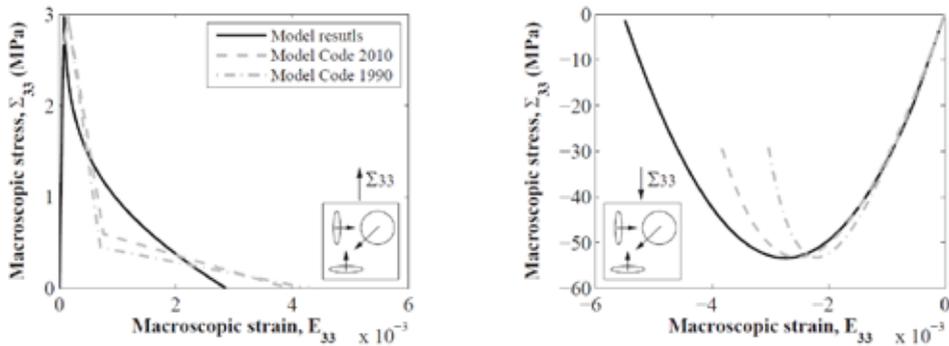
Figure 4: Simulation results of the micro-poro-fracture-mechanical model: resulting uniaxial tension softening and compression hardening-softening behaviour (Esposito and Hendriks, 2015).

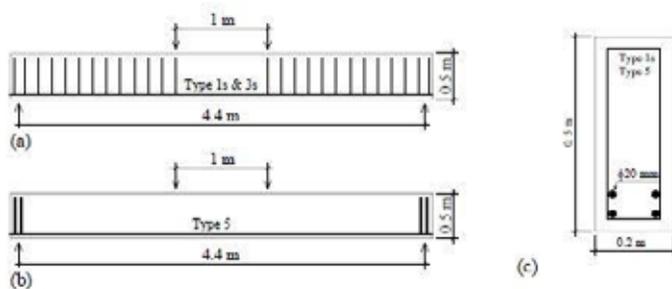
Figure 1 – Example of beam types and reinforcement arrangement.

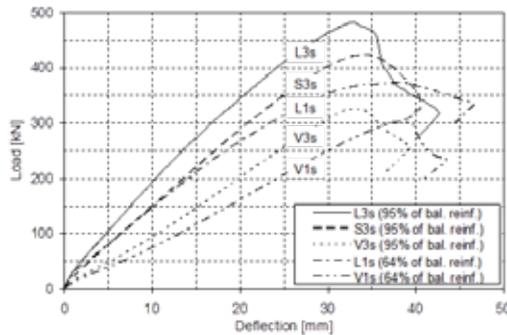
Figure 2 – Load – deflection curves of beams with shear reinforcement and the height = 0.5 m.
